Inca Quarrying and Stonecutting

Author(s): Jean-Pierre Protzen

Source: *Journal of the Society of Architectural Historians*, Vol. 44, No. 2 (May, 1985), pp. 161-182

JEAN-PIERRE PROTZEN University of California, Berkeley

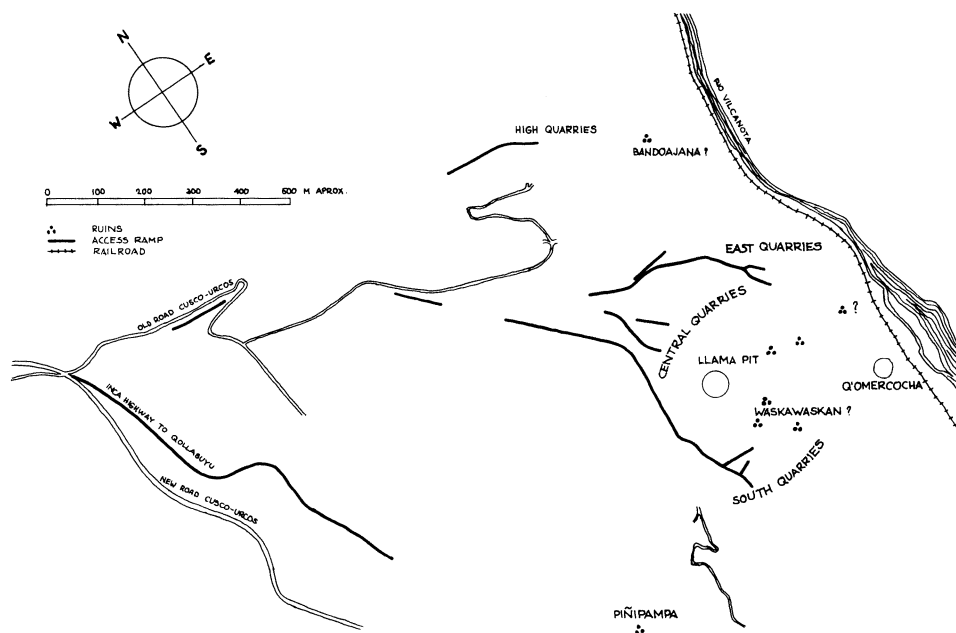
Fig. 2. Sketch map of the quarries of Rumiqlqa.

The sketch map of the quarries of Rumiqlqa (Fig. 2), made from an aerial photograph and from inspections on the ground, reveals a similar network of roads or ramps leading to different quarrying areas: the high, central, and south quarries.

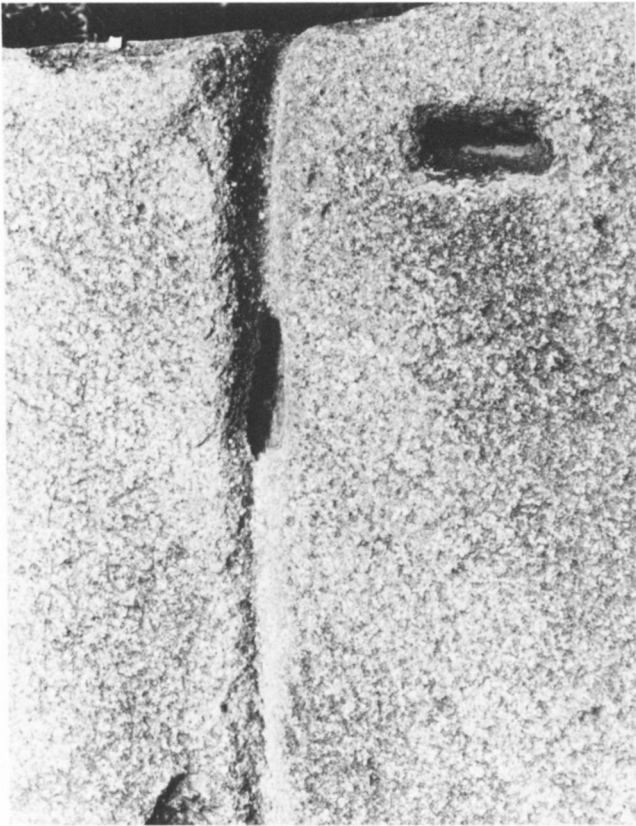
Fig. 11. Channel and wedge-holes on block of red granite on access ramp to Ollantaytambo. Pit marks and oval wedge-holes suggest that holes were bruised out.

Neither at Rumiqolqa nor at Kachiqhata did I encounter evidence conclusive enough to confirm the use of this technique by the Inca quarrymen. The only positive indications I found of the use of this technique were on a single block of red granite on the ramp up to the site of Ollantaytambo. A short channel, 145 cm long, 4 cm wide, and 2 cm deep, traverses the top face of this block. In the channel are three holes, from 10 to 13 cm long, 4 cm wide, 6 cm deep, and from 32 to 34 cm apart. Ten more such holes are to be found in the block, three of which are curiously staggered across the top face. The irregular shape of the holes, their rounded edges and bottoms, the sinuous tracing of the channel, and the pit marks in it strongly suggest that the channel and holes had been pounded out rather than

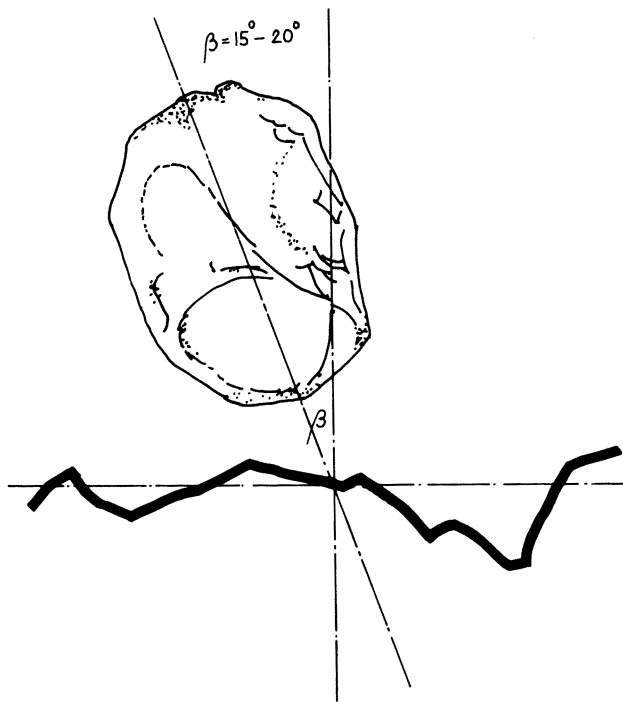
Fig. 17a. Directing the hammerstone at an angle of 15 to 20 degrees to the surface to be worked increases the efficacy of the strike.

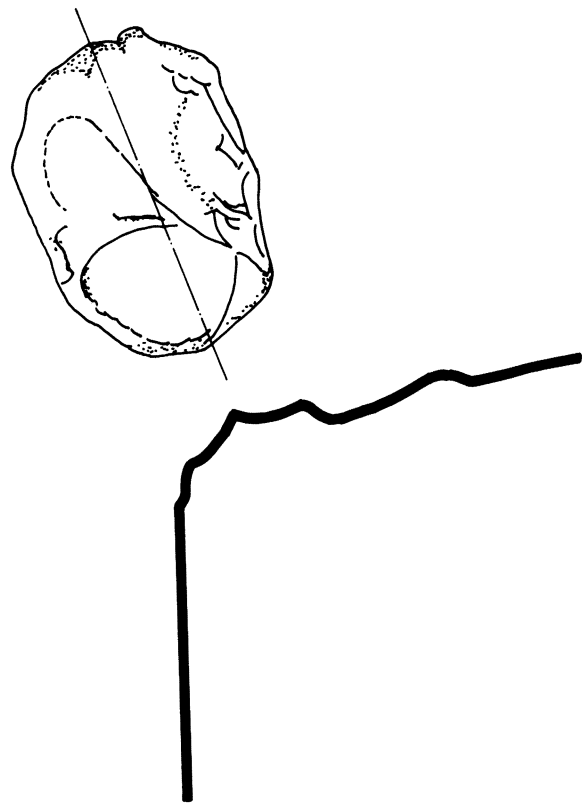
Fig. 17b. Once a face has been cut, one cannot simply turn over the workpiece to continue on another face. The big hammerstone would chip off large flakes at the edge.

When a face of a block has been cut, the block cannot simply be turned over for cutting the next face (Fig. 17b). The big hammer would most likely chip off large flakes near the edges. To avoid this danger, the edge must be drafted first with a small hammer, and with grazing strikes away from the edge (Fig. 17c). Only after the edge is drafted can one return to the technique of dressing a face (Fig. 17d).

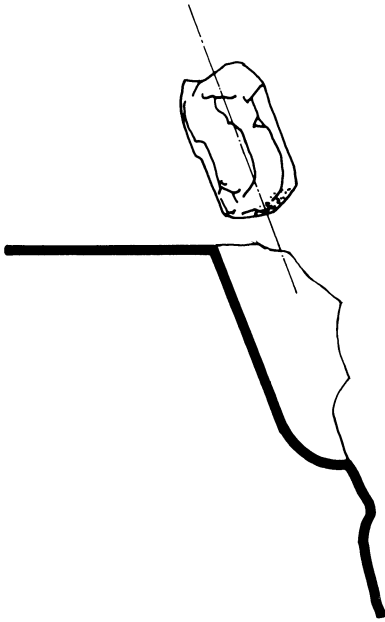
Fig. 17c. Before a new face is cut, one must draft the edges with a small hammerstone and with grazing blows away from the edge.

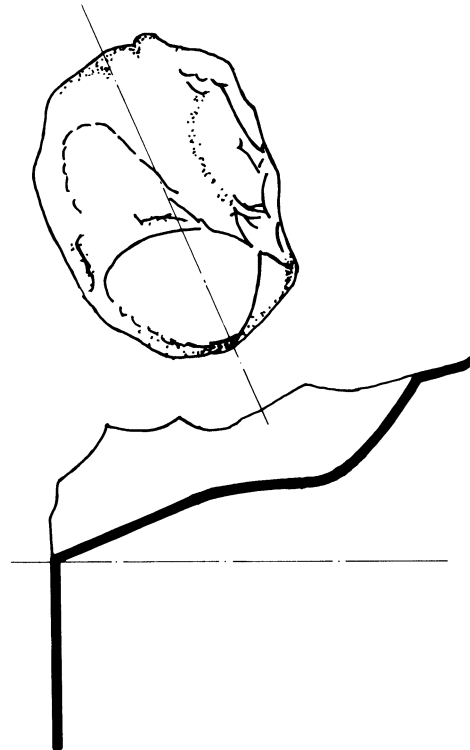
Fig. 17d. Once the edge is drafted, the workpiece can be turned over and the dressing of the next face may be started.

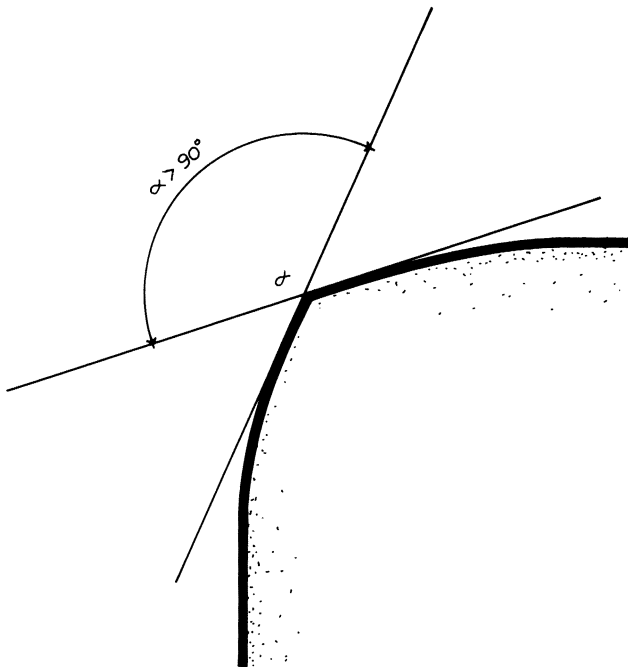
Fig. 20. As a result of the technique used to draft edges, the dihedral angle between two cut faces generally exceeds 90 degrees.

I noticed that, on most blocks, the dihedral angles between two adjacent faces, measured at the edge, seemed greater than 90 degrees (Fig. 20). Verification on a group of 31 blocks yielded an average dihedral of 117 degrees, with a range from exactly 90 degrees to an extreme of 132 degrees. This dihedral appears to be a direct consequence of the technique of drafting edges. The resulting protruding faces have the advantage of protecting the edges during transportation and handling. This technical detail of stonecutting accounts for the sunken joints that produce the chiaroscuro in Inca masonry.

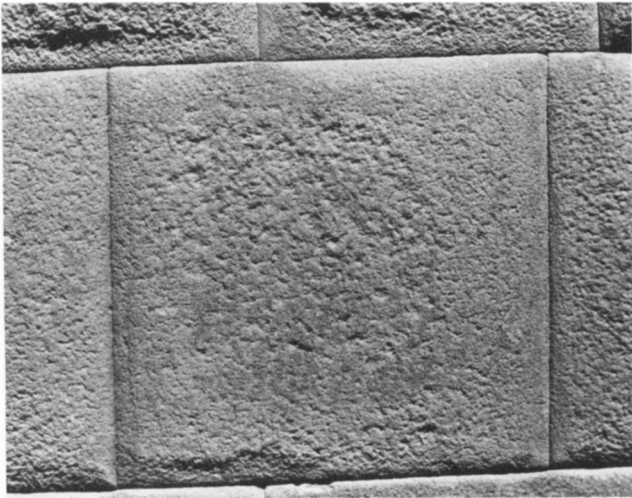
Fig. 21. Pit marks from pounding on andesite block in wall of Aqllawasi. Notice how pit marks get finer around the edges of block.

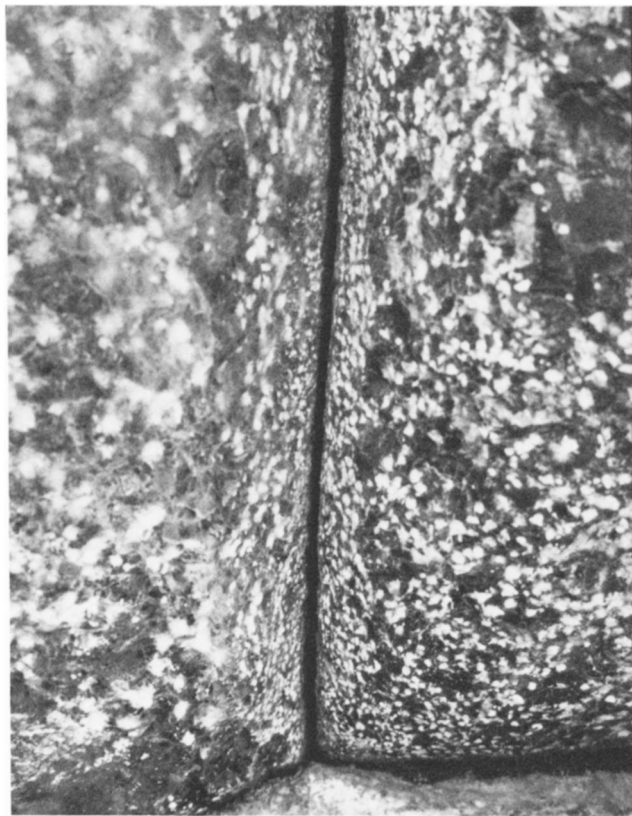
Fig. 22. Pit marks on limestone. Whitish spots are result of partial metamorphosis of limestone produced by the heat of impact of the hammerstone. The finer pit marks toward the joint suggest the use of smaller hammerstones.

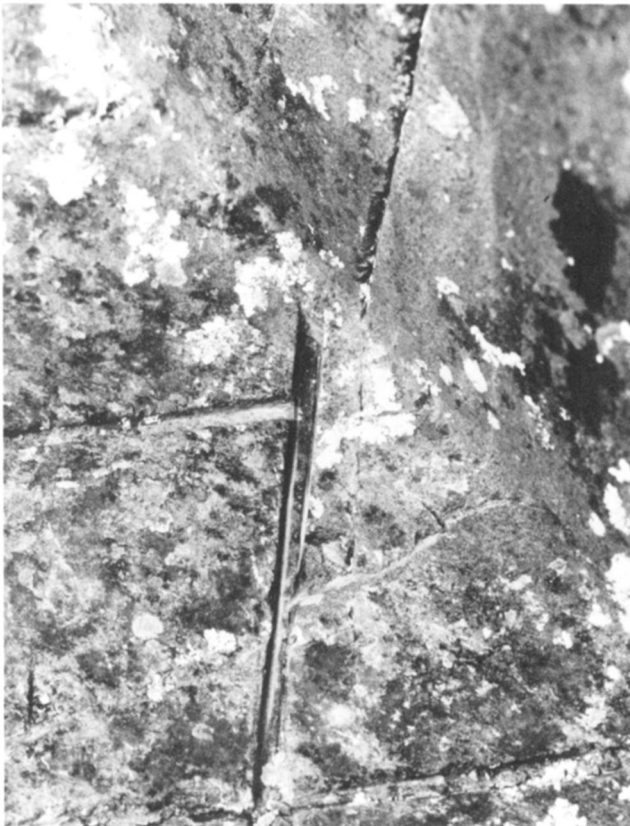
Fig. 25. Groove made of two cuts at Inkamisana. Cuts are result of abrasion and not of pounding.

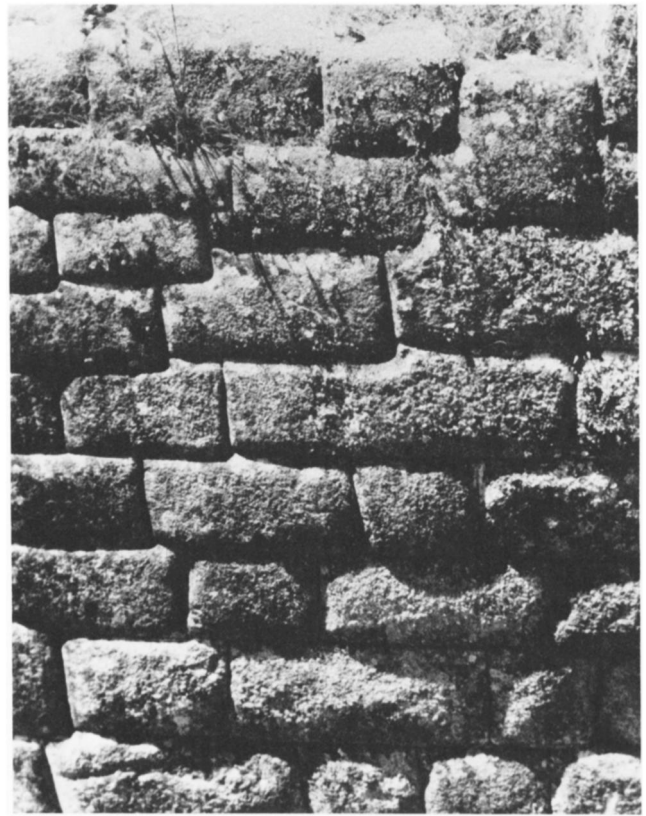
Fig. 27. "Hookstones" in Bingham's "Beautiful Wall" at Machu Picchu are a good illustration of the bedding-joint rule.

and gives a simple explanation for the wall section at Machu Picchu that so attracted Bingham's attention (Fig. 27). Of this wall he wrote:

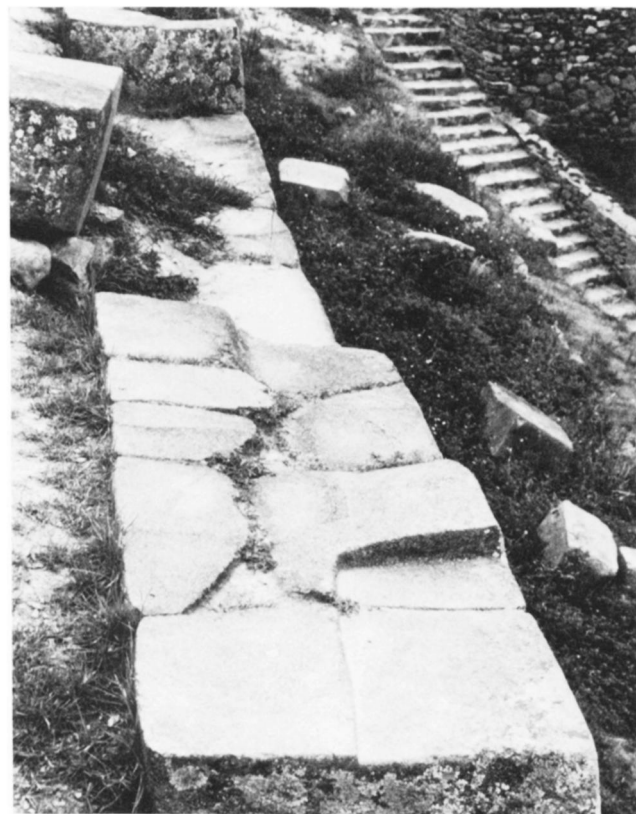
Fig. 29. Bedding joints cut to receive next course of stones. Such cuts were not obtained by grinding stone against stone, but were pounded out.

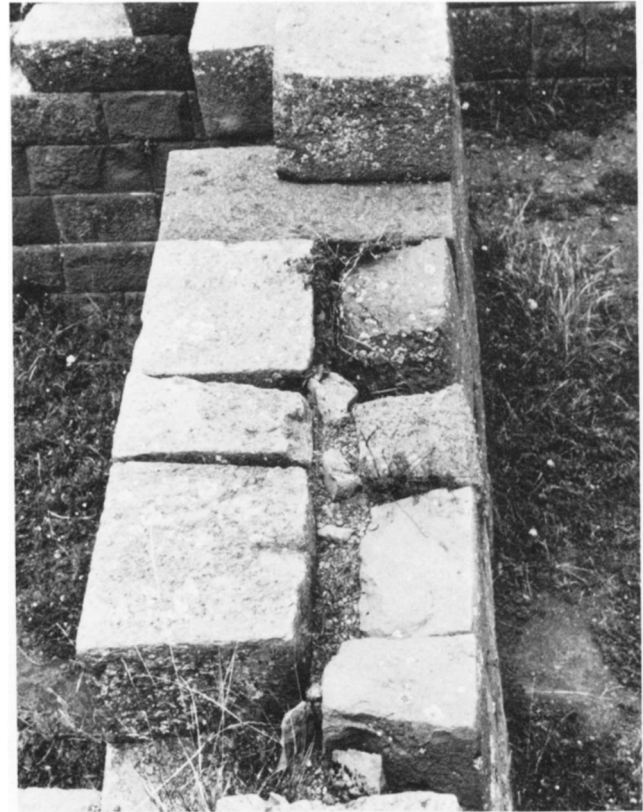
Fig. 33. Sometimes the building blocks were fitted only along a shallow band close to the visible face of the wall, while the interior of the joints was filled with rubble.

The lateral or rising joint differs from the bedding joint in that the fit observed from the front is often only a few centimeters deep, with the interior of the joint being filled with rubble (Fig. 33). Harth-terré hailed this method of fitting stones as the technical secret of the "wedge-stone" (*pedra-cuña*) which allowed the Inca stonemason to reduce the fitting work to only a thin band around the edges of the stones.¹⁸ While this shallow fit is common, it rarely applies to bedding joints and is by no means the rule for rising joints. In many instances the blocks are fitted with the same care over the extent of the joining plane (Fig. 34). Nevertheless, as I will show below, wedge-stones do play an important role in Inca stonemasonry.

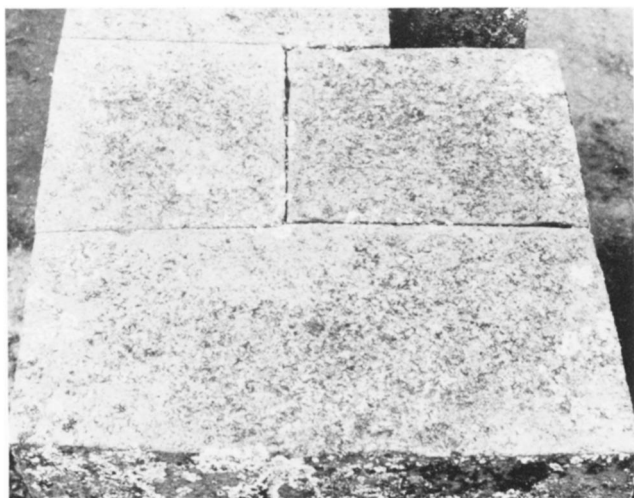
Fig. 34. Sometimes the building blocks were fitted carefully over the whole extent of the joining plane.

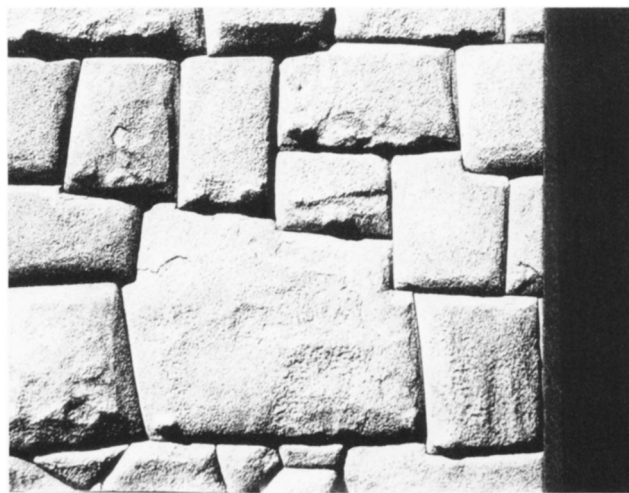
Fig. 36. "Twelve-angle" stone in a wall of the palace of Inca Roca is the simple result of the fitting technique.

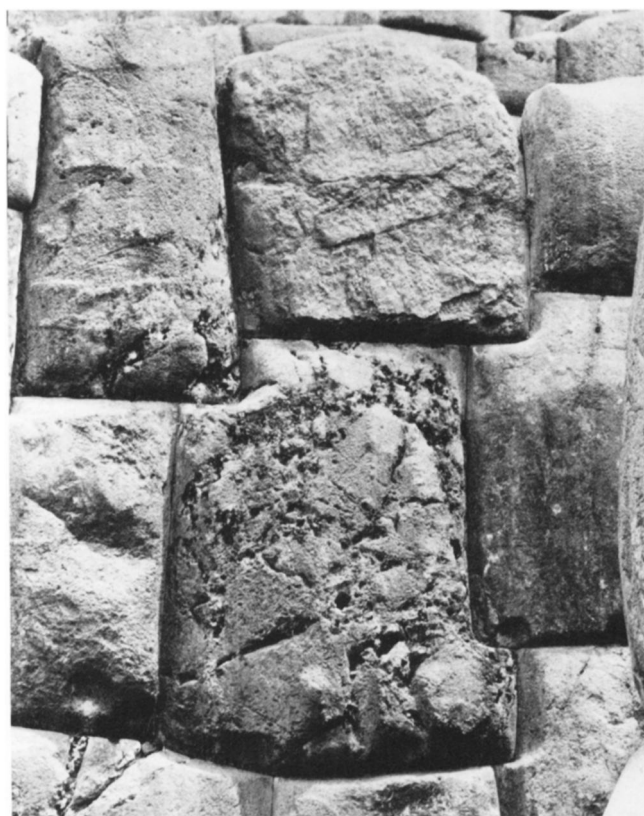
Fig. 35. Illustration of the combined effect of the fitting of bedding joints and lateral joints at Saqsaywaman.

With regard to the bedding joints, I have made an observation that can be formulated as a general rule: *the bedding joint of every new course is cut into the top face of the course already laid below it.* The rule is manifest, for example, at Saqsaywaman (see Fig. 35)

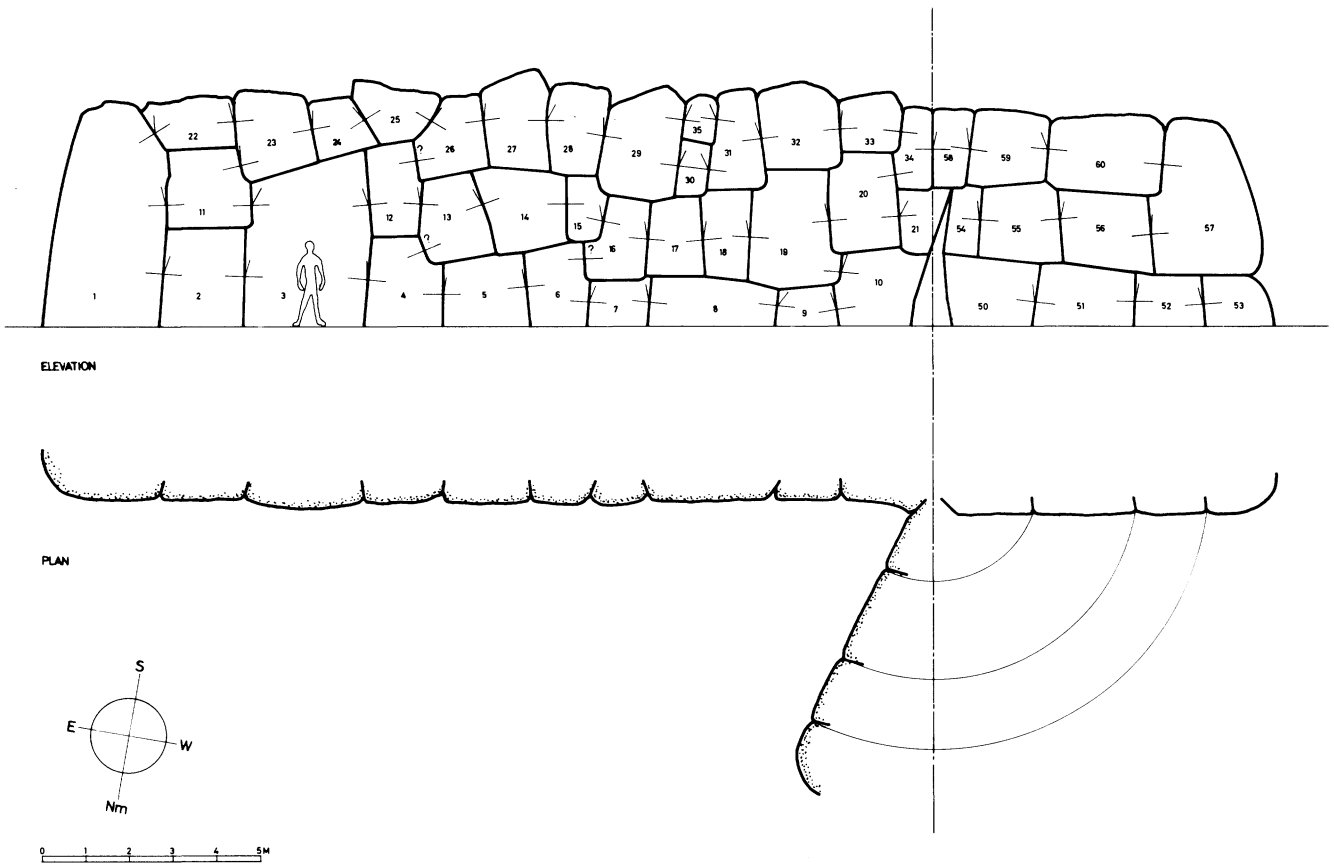
Fig. 37. Plan and unfolded elevation of wall sections 26 and 27 of the first rampart at Saqsaywaman showing the angles formed by the joining planes and the plane of the face of the wall.

first rampart shows the orientation and magnitude of the angles formed by the joining planes and the plane of the face of the wall (Fig. 37).¹⁹

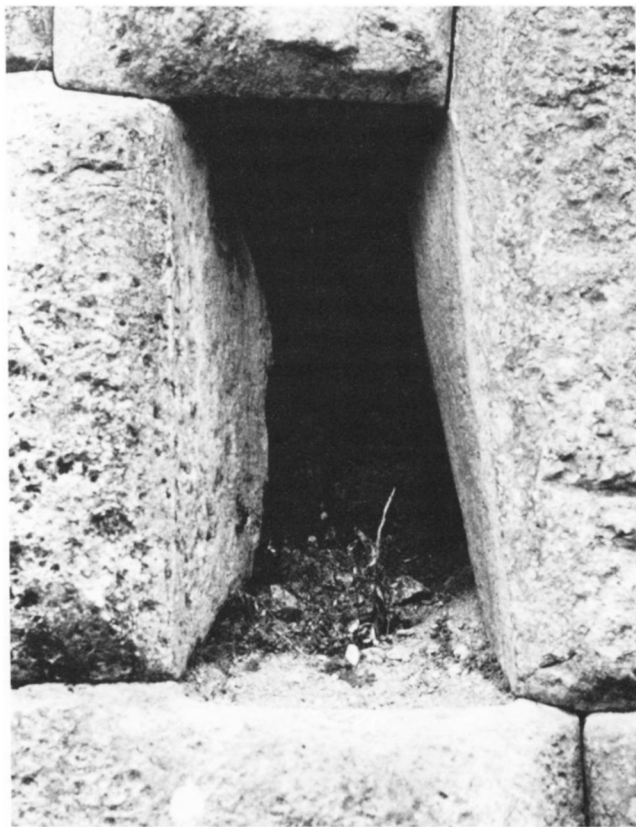
Fig. 38. Gap left by a keystone fallen out of bond. Notice taper of the sides of the gap leaving a wedge-like hole. Since the width of the hole is wider at the bottom than at the top, the keystone must have been introduced from the front.

The reason I think that some keystones were introduced from the front is manifest in a gap found in the second rampart at Saqsaywaman (Fig. 38). The tapering sides of the gap indicate that it held a keystone that has fallen out of the bond. Since the width is broader at the bottom of the gap than at the top, the keystone must have been introduced from the front. If, as I suspect, the Incas used earthen embankments to raise the building blocks into position, it would make sense to assume that keystones were always inserted from the front. Each of the courses in these walls proves to have a block that can reasonably be regarded as such a keystone: blocks 15, 58, 30, and 35, and possibly 28 and 25. The course formed by blocks 20 to 57 does not have a keystone because it does not need one. Block 57 is a cornerstone which could easily be put in place last. Cornerstone 1 was most likely erected after blocks 2 and 11 were in place.
